Main Factors of Improving Containerships' Salvage Efficiency

Liang Xinggao Huang Yiwei
Zhejiang Manyang Shipping Co., Ltd.

【Abstract】 The article takes 'Hongyuan 02' for instance and discusses the main factors of a successful salvage when similar or larger containerships encounter marine accidents.

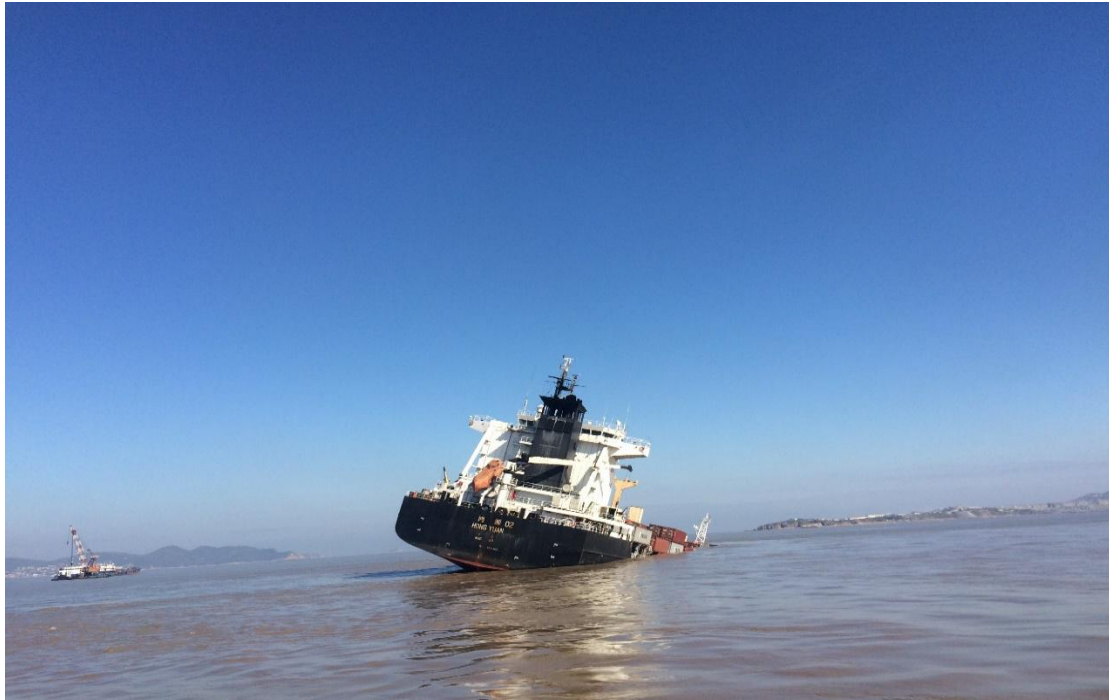
Diagram 1: General Situation of the Wrecked Ship

Ship Condition: approx. 10° leaning towards the front; approx. 15°~20° leaning towards the right hand side

Drowning Condition: forepeak, 1#, 2#, 3#, 4#, 5# cargo holds were drowned: 1# – 3# cargos were below water surface; half of 4# hatch and 5# hatch was above the water, and sea water flew in through the bulkhead; the cabin was flooded slowly; 2/3 of the deck near starboard and prow deck on the port side were drowned.

0#-95# flank was hanging; 95#-240# flank touched the seafloor; Prow stuck into seabed

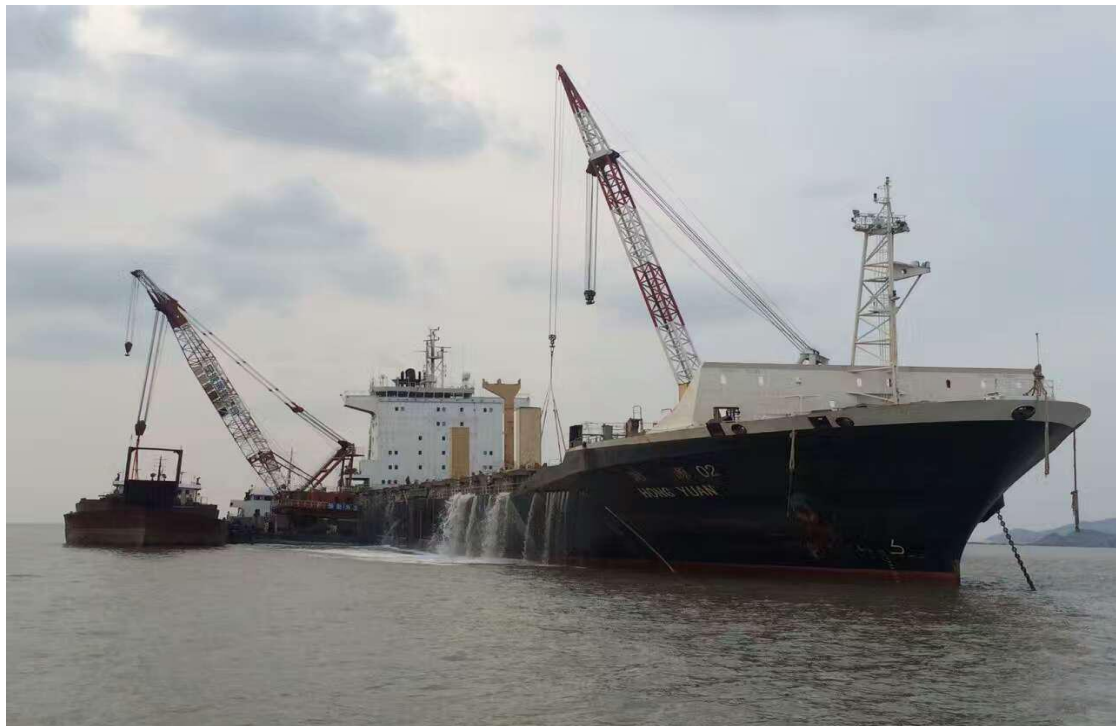
Diagram 3 “Hongyuan 02” refloated

1. Prevented the cabin from being flooded and the risk of drowning
 - 1.1 Made the leaning angle from 20° to 4° by load-off. The deck in front of the cabin was lifted to 3-4 meter height instead of drowned under the sea level.
 - 1.2 Battened down the hatches and pumped water out of 3#, 4# and 5# so as to prevent the drowning of the stern and hazards to the equipment.
 - 1.3 Anchored two sides of the stern so as to avoid drifting.
 - 1.4 Avoided secondary accident
2. Salvaged all the containers and reduced the profit loss of the shipowners and stakeholders.
